MEMORANDUM

SUBJECT: ACTION MEMORANDUM request for an Emergency Removal Action at the Tilton Plating Site, Vermilion County, Tilton, Illinois (Site ID# B589)

FROM: Cindy Nolan, On-Scene Coordinator
Emergency Response Section II

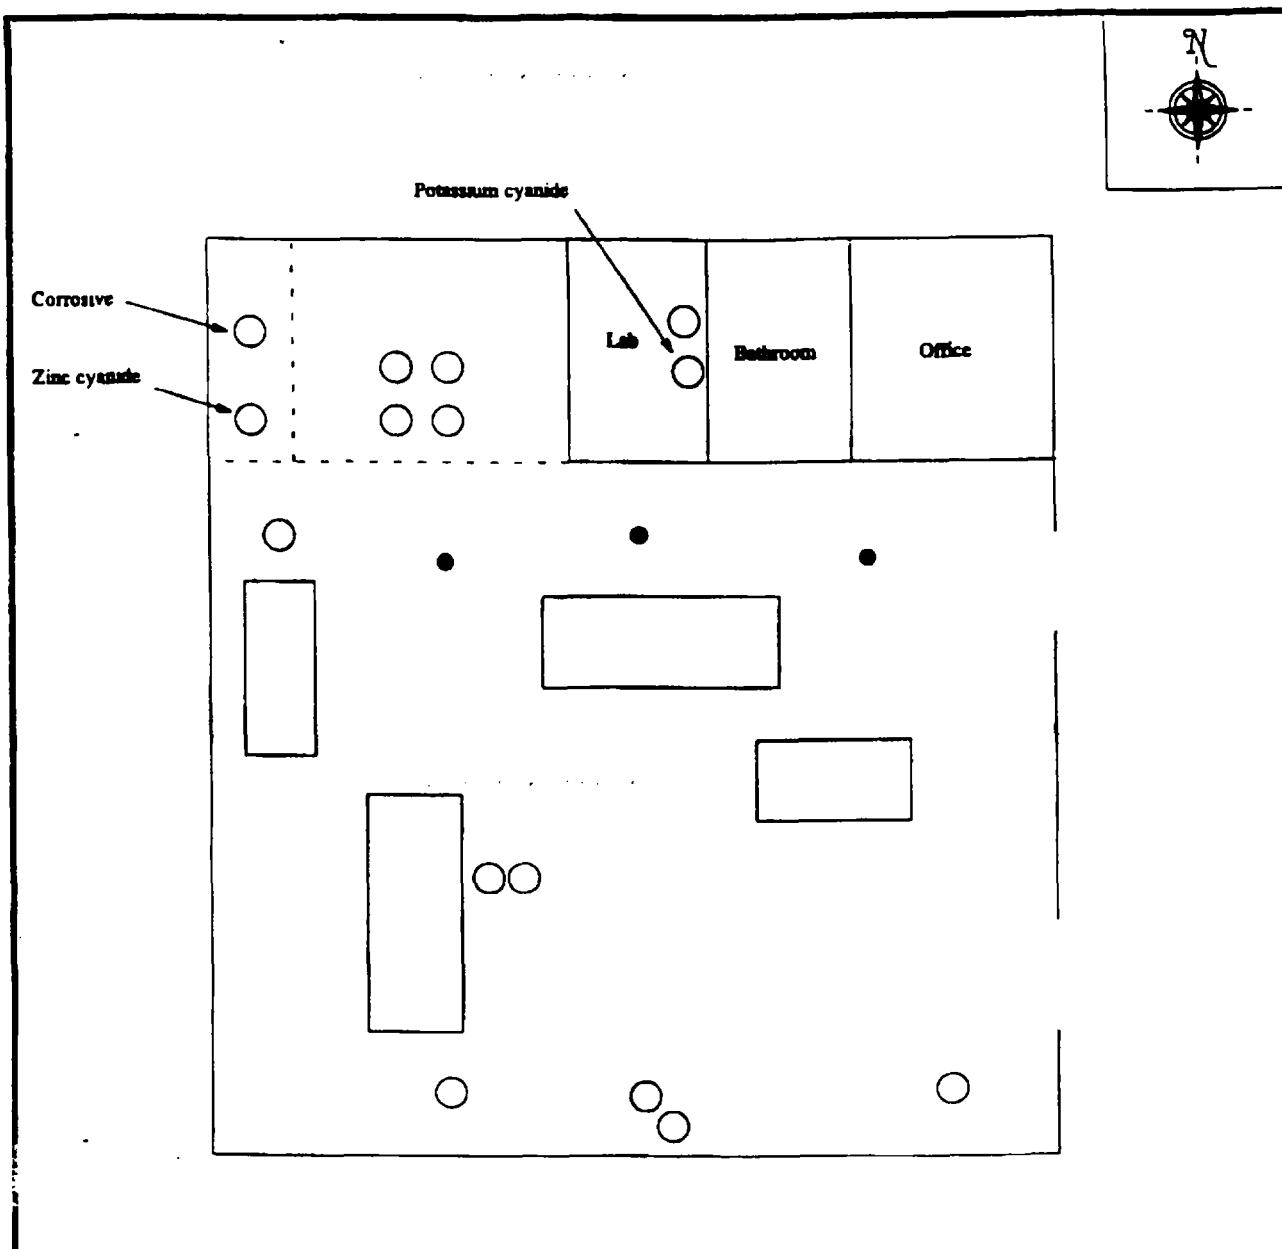
The building is in a severe state of deterioration, has a leaky roof and several holes in the walls. Both doors to the building are in deteriorated condition. Approximately 25 drums and other containers of hazardous materials were stored unsecured outside of the building. Approximately 50 additional drums, containers,

and several open plating vats were located inside the building (Figure 3).
